**WOODBIDGE RESEARCH FACILITY
1995 ASBESTOS SURVEY**

WOODBIDGE, VIRGINIA

FINAL REPORT

October 6, 1995

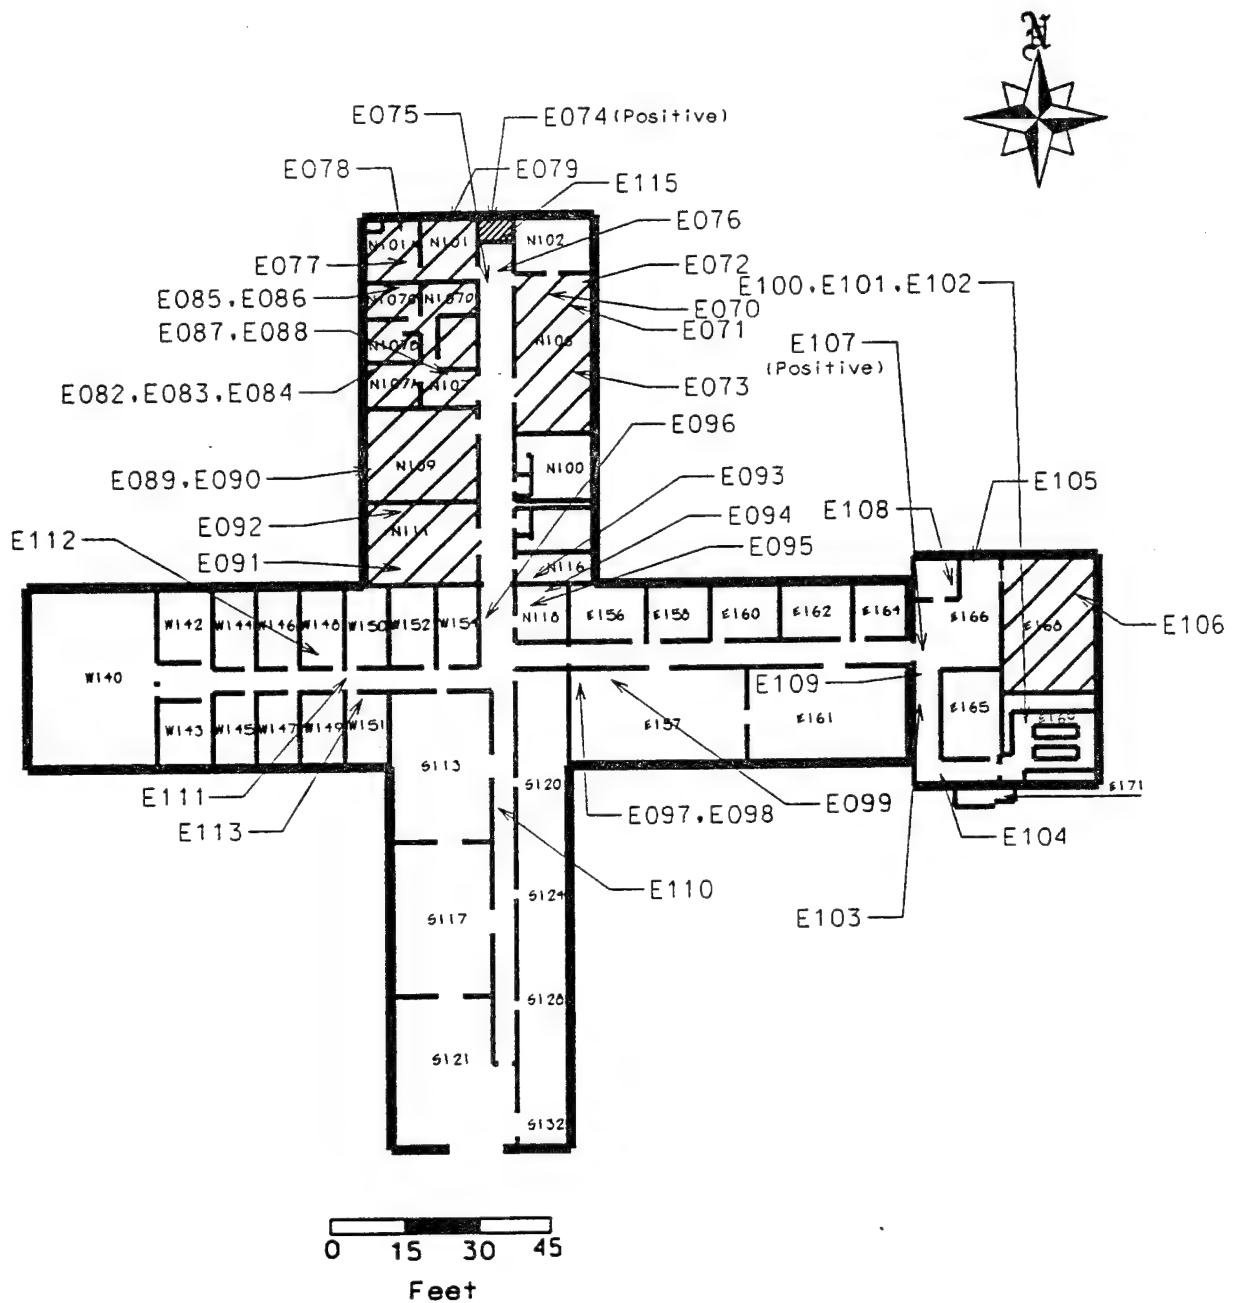
Building # 201

- Two of the forty-four samples collected from building 201 are ACM. The 12"x12" beige with white and gray mottling floor tile in the lobby of building 201, contains 5 to 10 percent chrysotile asbestos. The white glue on the duct work above the suspended ceiling in room 166 contains 5 to 15 percent chrysotile asbestos.

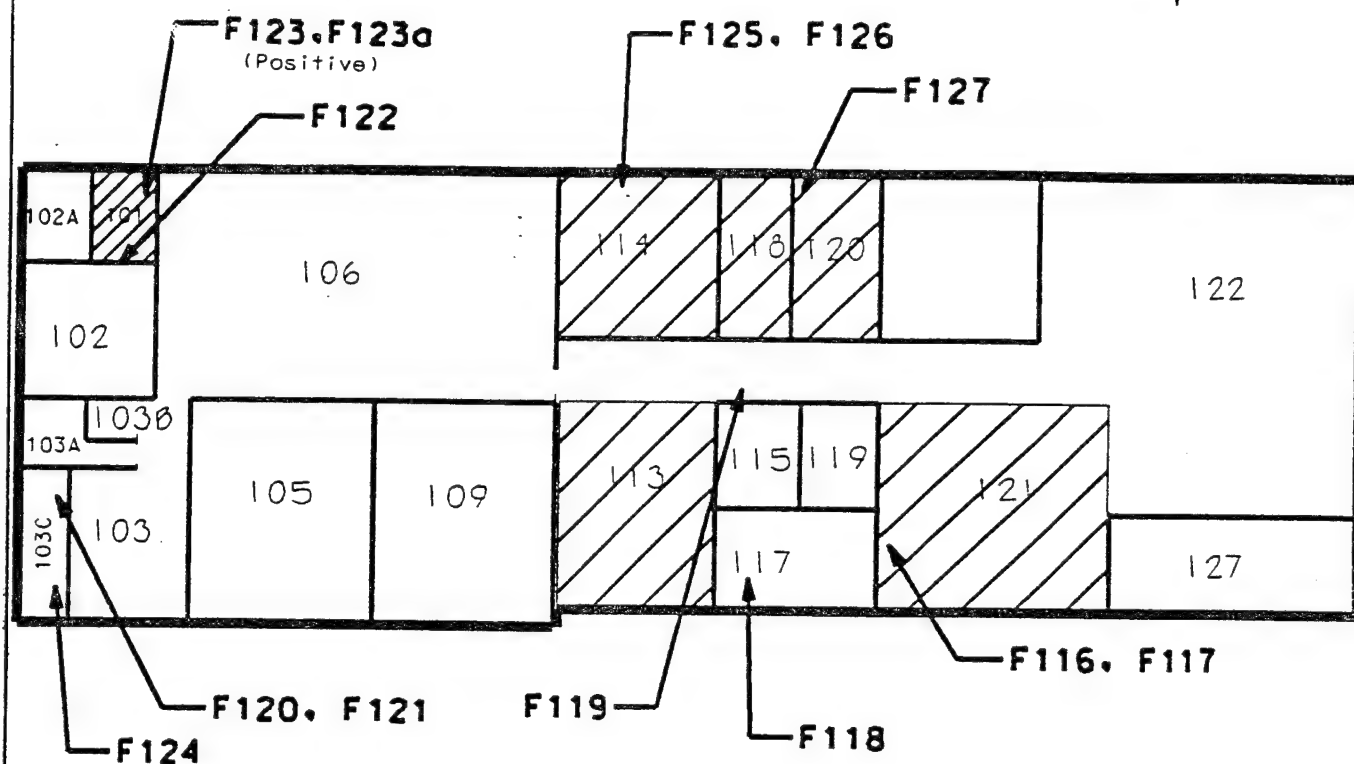
Building # 202

- One of the eleven samples collected from building 202 contains asbestos. The 12"x12" green and gray floor tile with white streaks in room 101 contains 5 to 10 percent chrysotile asbestos. The mastic from this tile is also an ACM containing 1 to 5 percent asbestos.

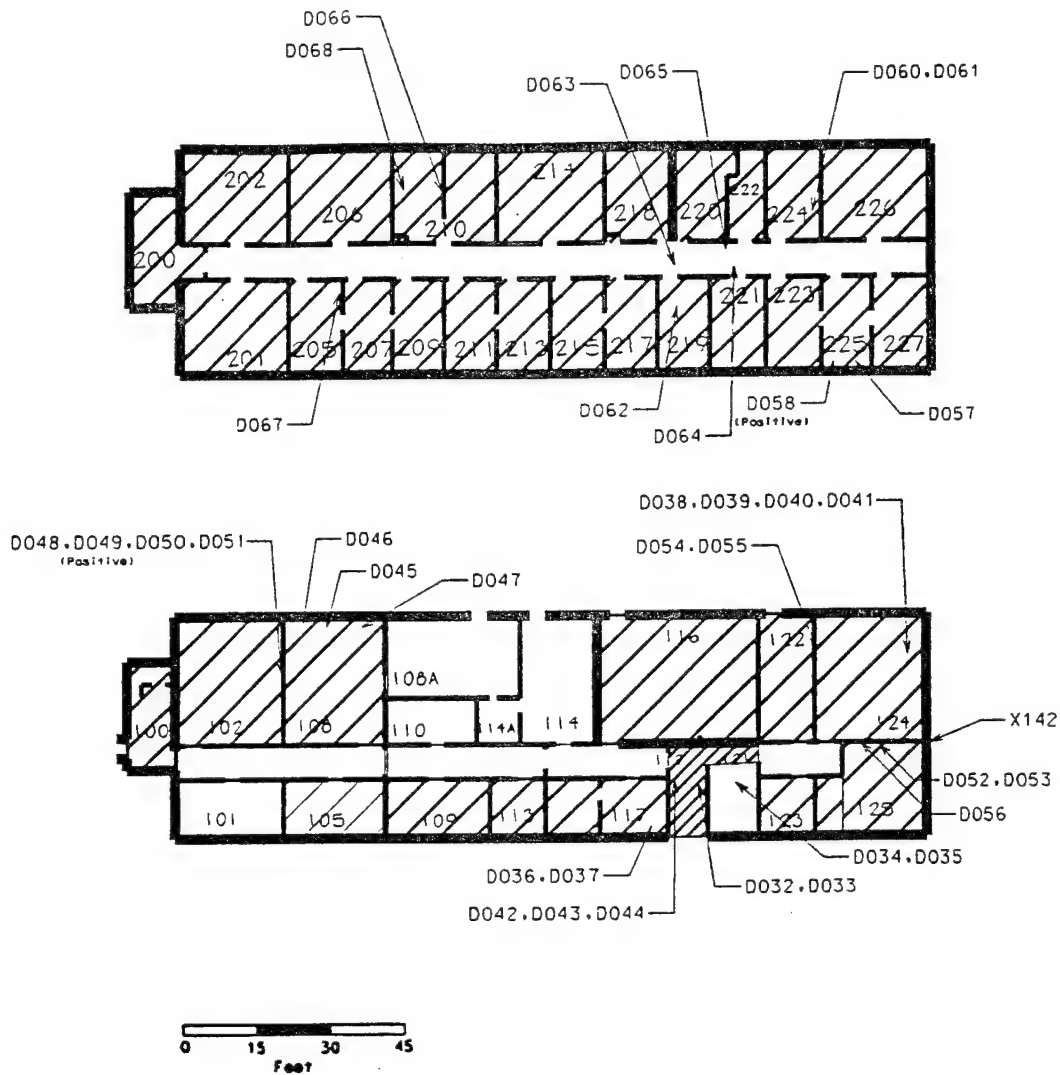
Building # 203

- Two of the thirty-eight samples collected from building 203 are ACM. White glue on the duct work in room 102, and the black glue on the duct work in room 225, contain 5 to 10 percent chrysotile asbestos.

The 9"x9" floor tile assumed to be an ACM is present in buildings 101, 201, 202, and 203 at the locations noted on the drawings in Appendix A. This floor tile is in good condition except a water damaged area in room 108 of building 203. The water damaged area is ten feet in diameter with loose warped tiles exposing another layer of 9"x 9" tiles underneath them. The asbestos in the tile is not friable and does not pose a threat to human health. According to State and Federal Regulations, the tile does not have to be removed. According to the 31 October 1994 memorandum from the Office of the Under Secretary of Defense, Subject: Asbestos, Lead Paint and Radon Policies at BRAC Properties, the ACM is not to be removed. ACM is only removed when it is "of a type and condition that is not in compliance with applicable laws, regulation, and standards, or if it poses a threat to human health at the time of transfer of the property." Horne Engineering completed a USAEC Asbestos checklist for the 9"x9" tile overall and for the water damaged area, both have an assessment index of "E - Monitoring."

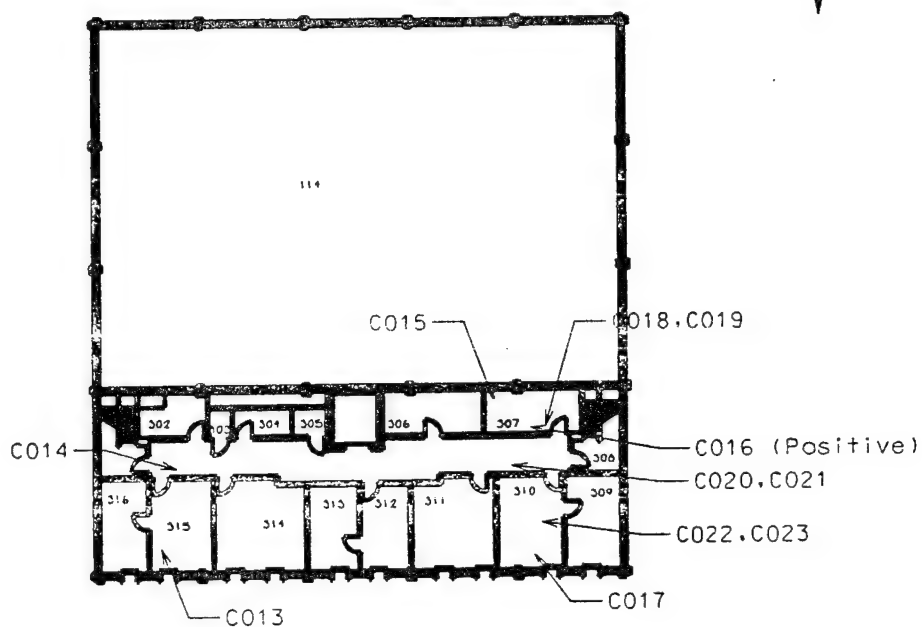
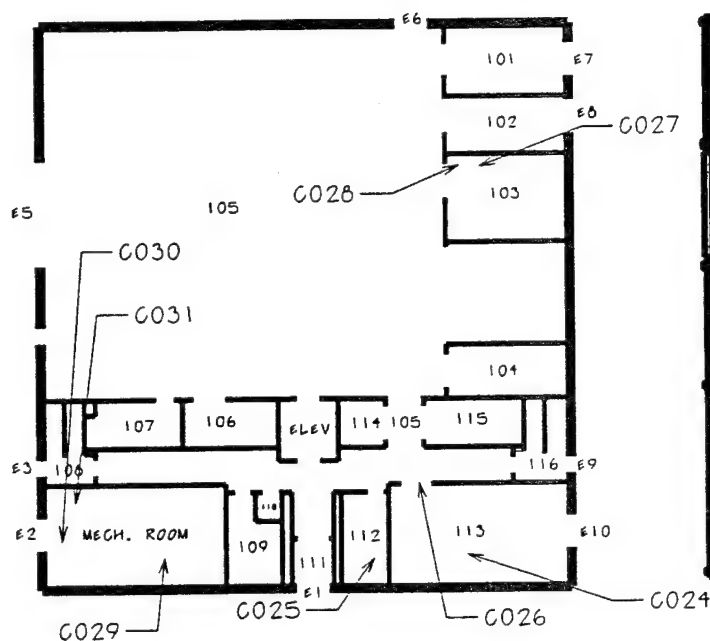
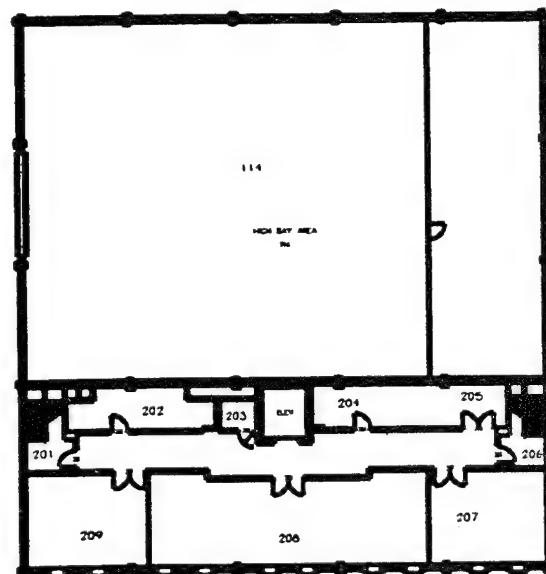
Building # 211

- One of the nineteen samples collected from building 211 is an ACM. The white duct glue on the duct work above the suspended ceiling in room 307 contains 10 to 20 percent chrysotile asbestos.
